To learn more about how concussions are occurring in rear-end collisions by examining concussed patients' crashed vehicles and extracting event data recorder (EDR) data.

Table 1. Demographic, clinical, and crash characteristics of two patients who were concussed by rear-end collisions and whose vehicles were examined.

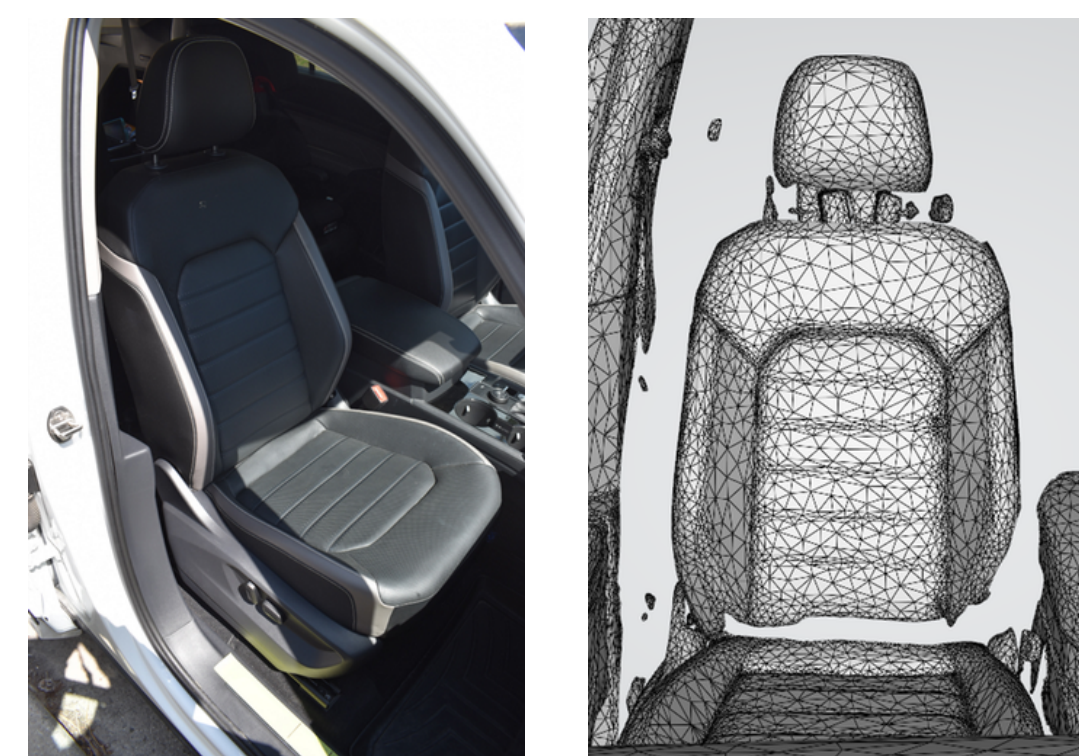
Figure 1. 3D scan of the vehicle seat (Patient 1).

- EDR (or "black box") data
- Seat and head restraint positions
- A 3D scan of the vehicle interior
- Photographs of vehicle damage

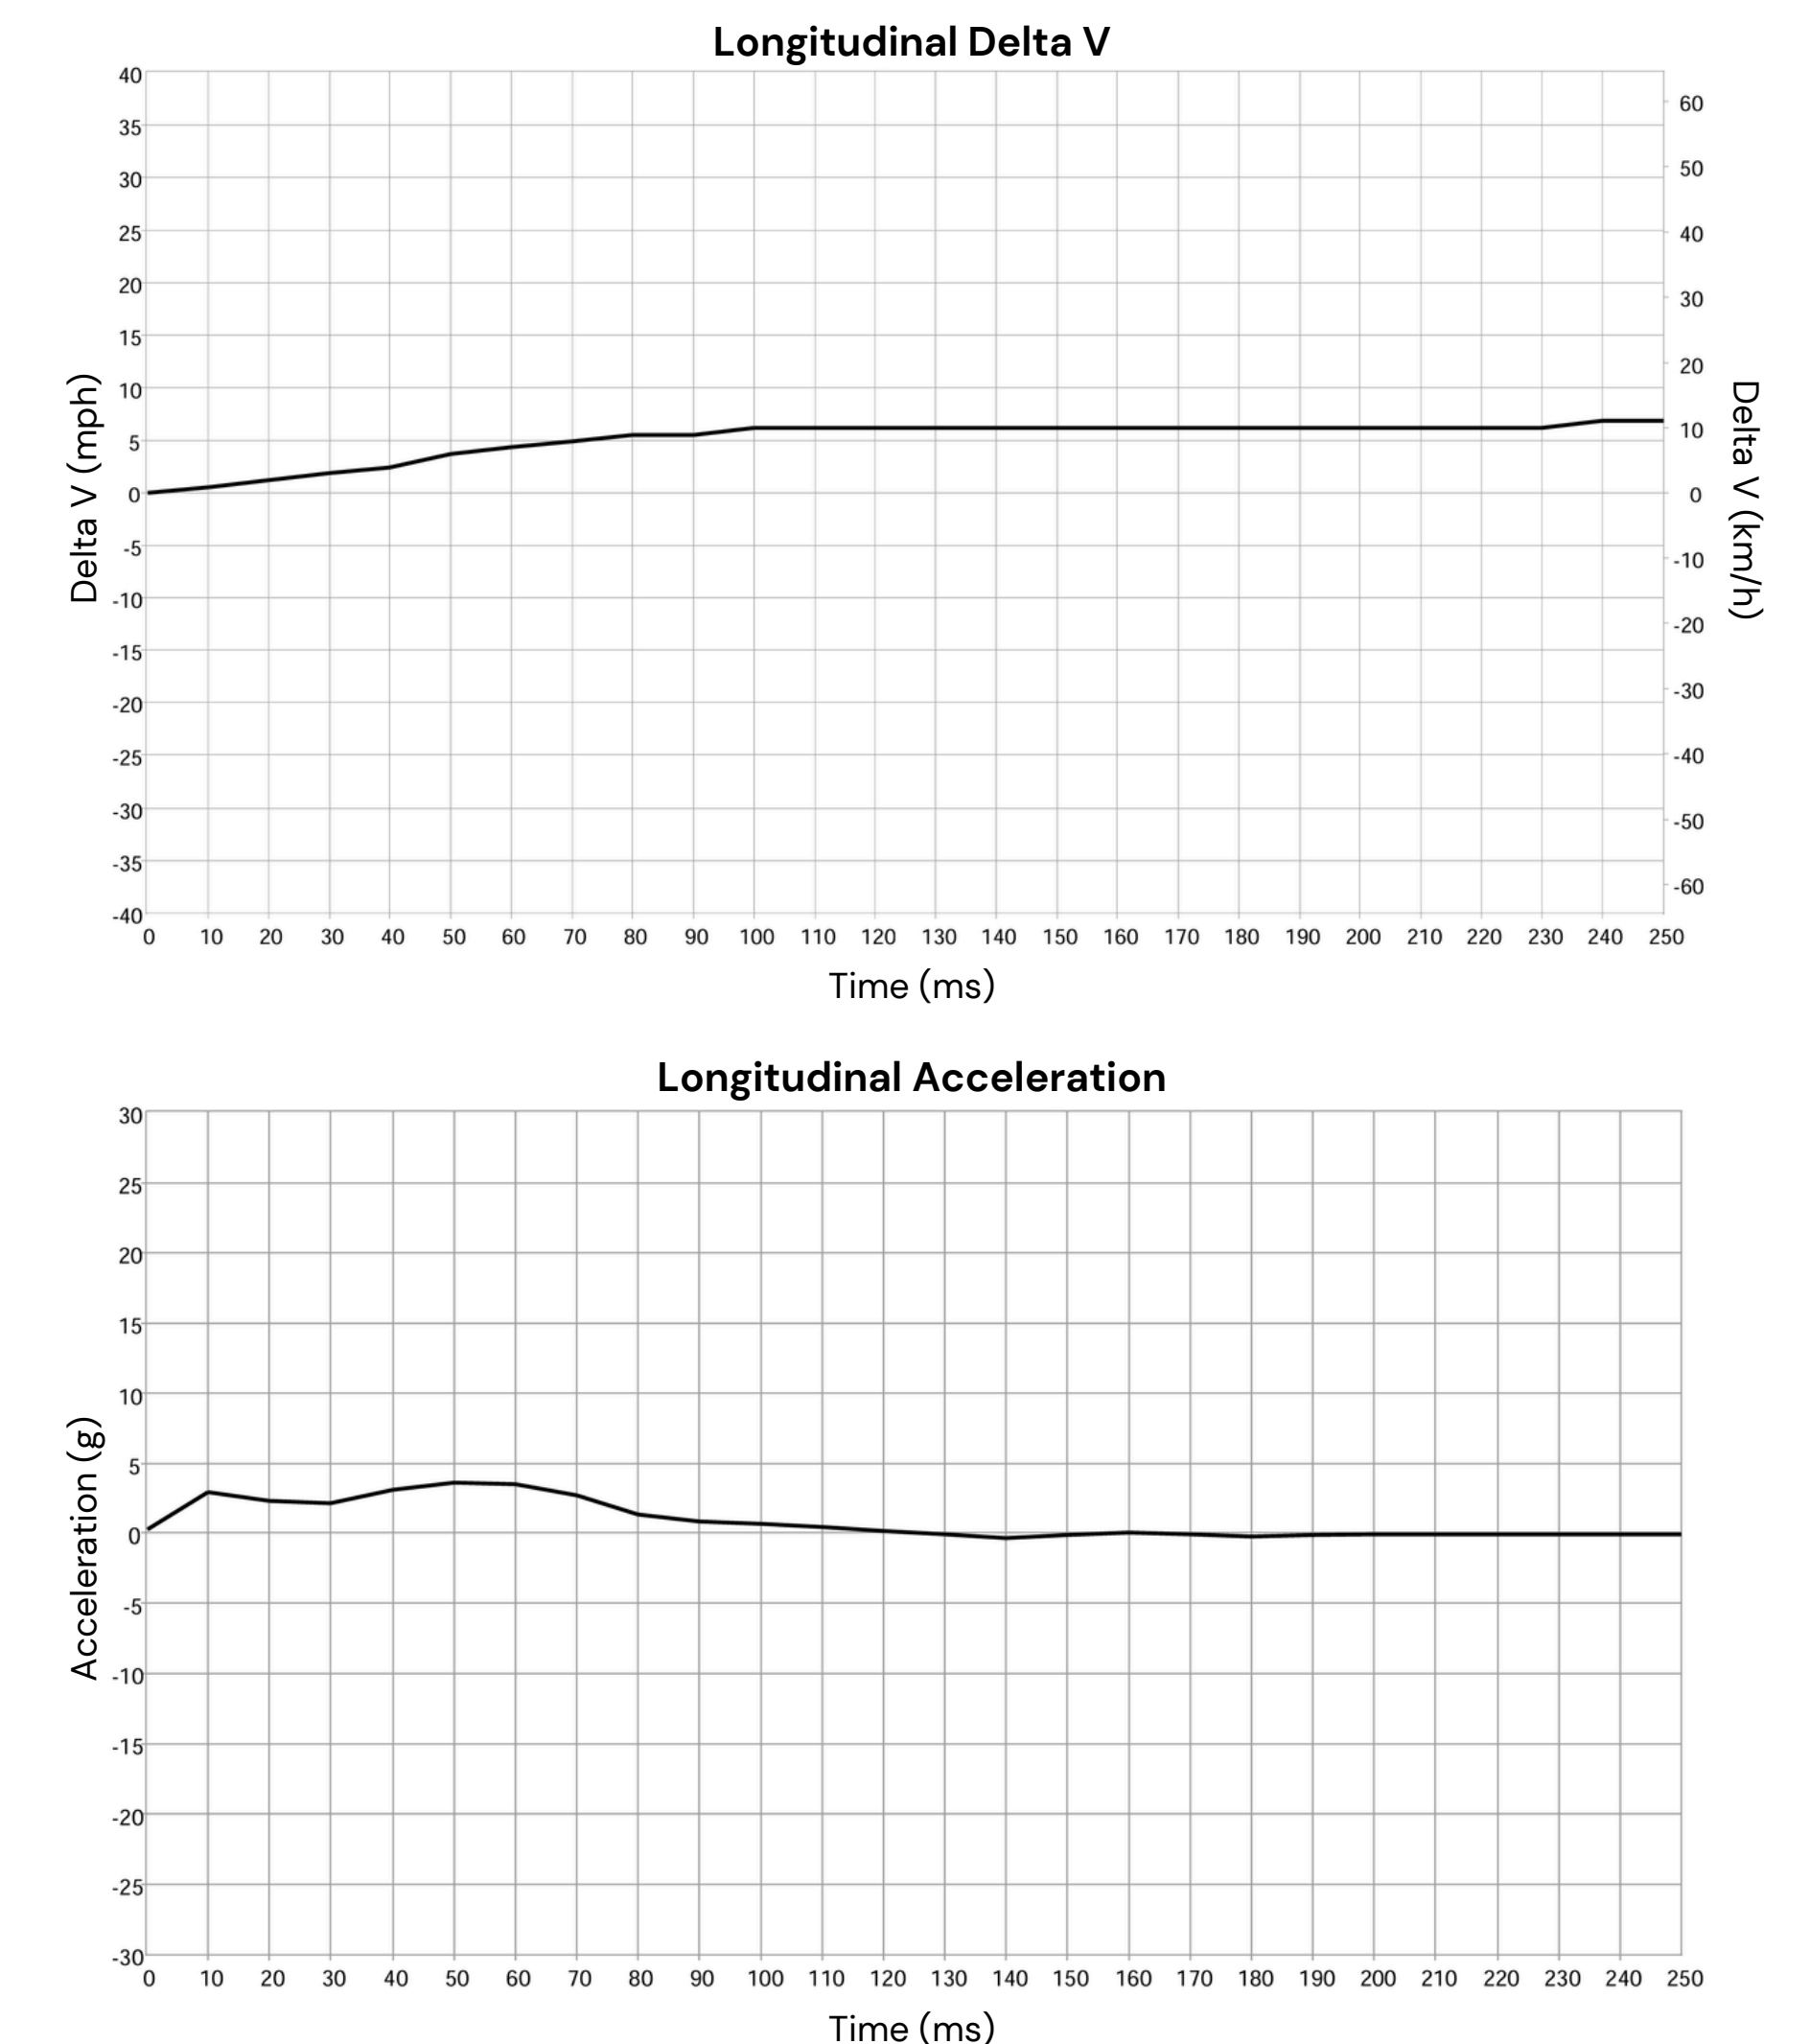
Figure 2. Crash pulse data showing the longitudinal delta-V and acceleration measured by the vehicle's EDR (Patient 1).

Both concussions occurred from low-speed rear-end collisions. One patient experienced a speed change of 11 km/h during the crash and no vehicle safety systems were deployed; the other patient was involved in a crash that was not severe enough to trigger the event data recorder, implying a speed change of less than 8 km/h.
